► [TRS](#) > [Discussions](#) > [Submit Tech Info For Tech Library](#)

Electric T-Case motor fix, A fix not posted yet ?

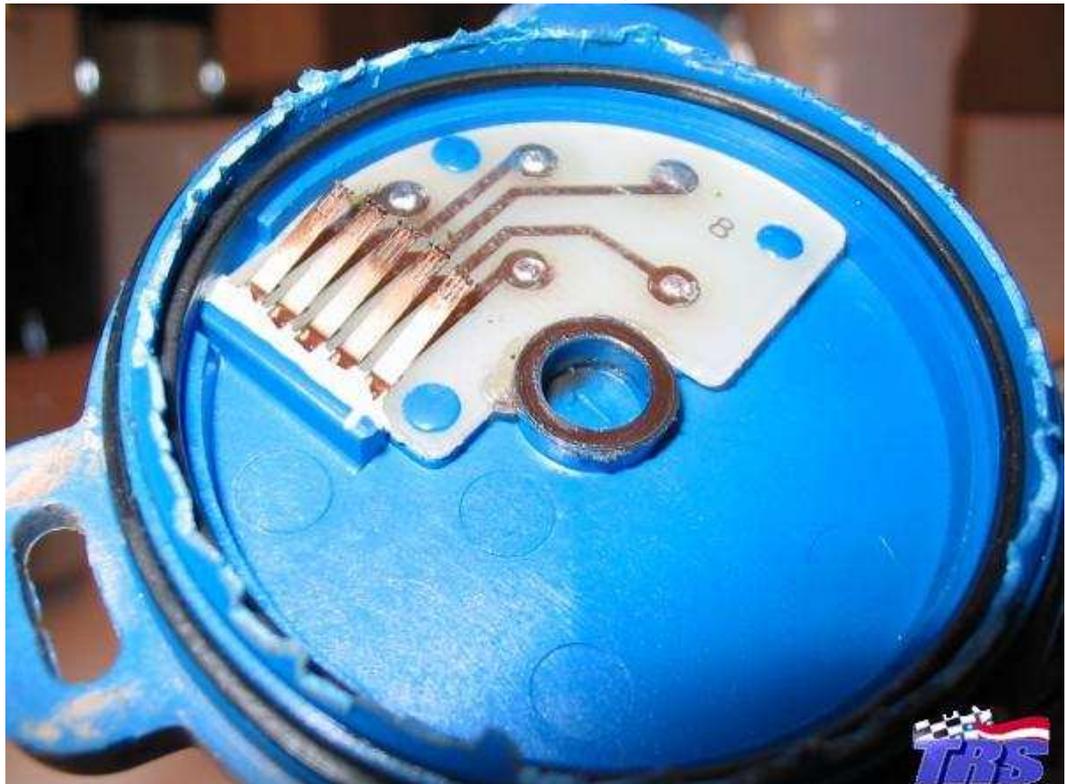
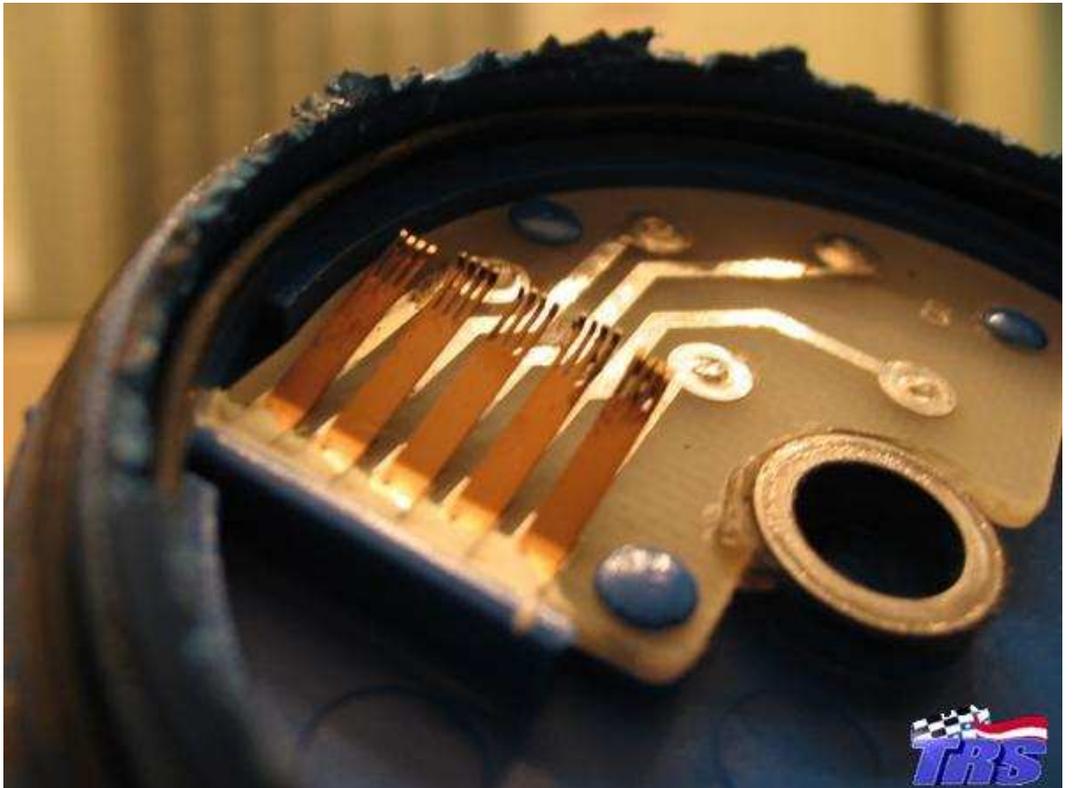
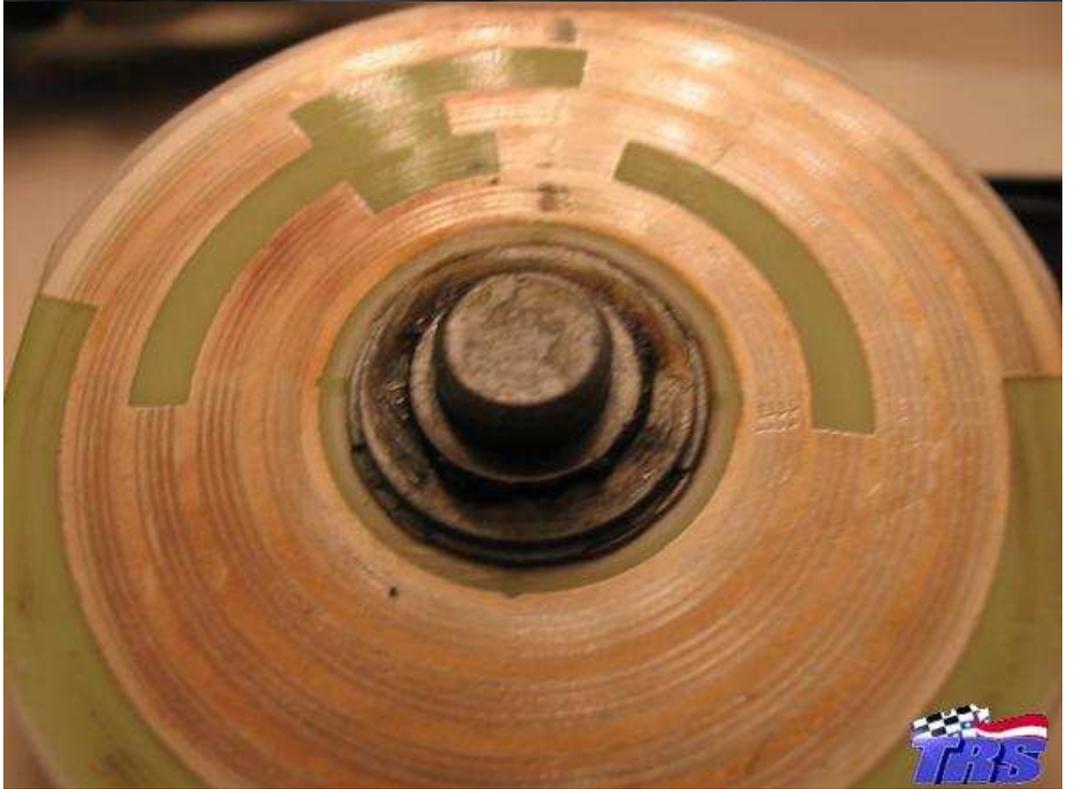
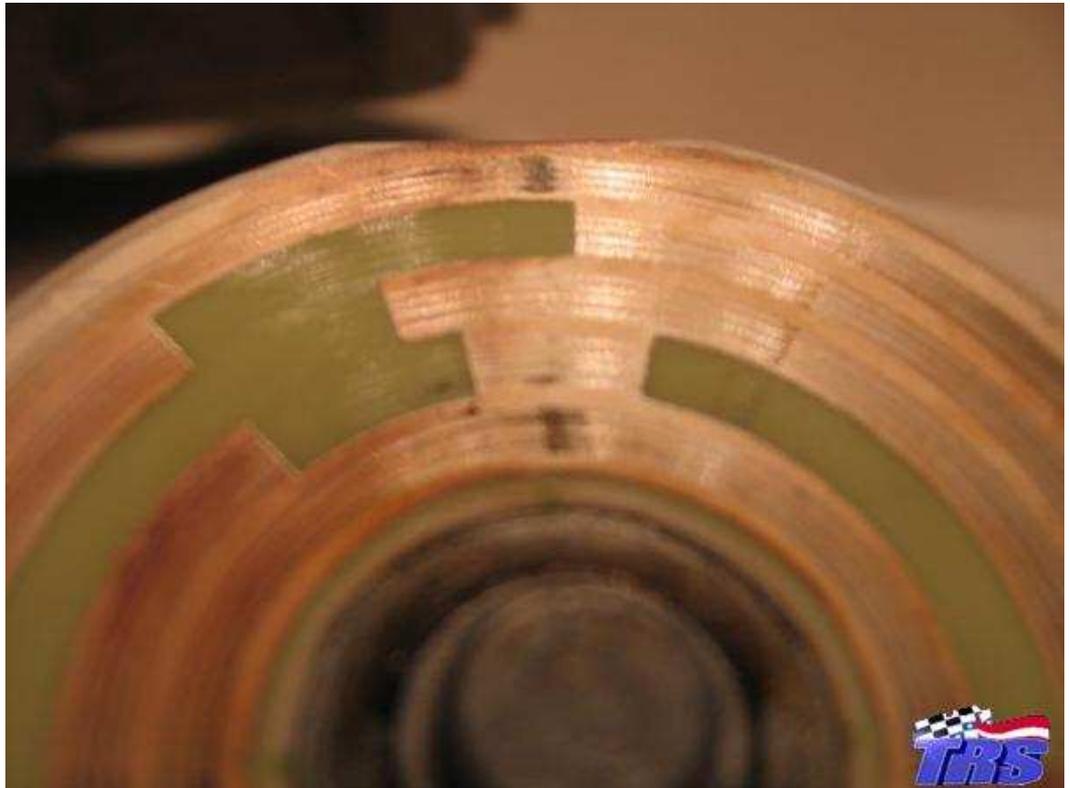
I don't have too many pics, but they're not really needed... Here's what I did....First, I tried all the fix ideas on the site including the shift motor rebuild and it still did not work.(still got the repeated clicking noise followed by the flashing lights) so I felt I had nothing to lose by tearing open the blue cap. I used a small flathead screwdriver to break away the tapered plastic seal.(not too much, just enough to separate the two halves) Once separated, pull the contact disk out and you will find the worn spots where it has been in the 2 hi position for most of the trucks life.

Take a dremmel tool or a file and smooth out the havoc you caused with your screwdriver on the housing. Clean all the contact points with alcohol and Q-tips. Use light pressure with your small flathead screwdriver and bend all four drag fingers back into the position where they will make firm contact with the position sensor disk, but use care not to over do it. If you do, the fingers will dig into the disk, killing the fingers and making deeper grooves that caused the problem in the first place. Use good quality dielectric grease and lubricate the disk and fingers. Put the wheel back into the cup trying to keep it in the 2 hi position, (not too important though, since your shift motor took a dump in 2 hi the blue cap can only be put back on the same way), put a light coat of grease on the rubber o-rings that seal the cap and put the top back on. I used a few drops of super glue to hold it in place during the re install. Put it all back together and throw it back in to your truck. Hopefully this will fix your problem. My T-case has worked flawlessly for quite some time after doing this and I`m baffled why no one else has tried it yet. Good luck and let me know how it works. 🙏
