## 3 Amigos due to SVS Fault – Finding & Solving

**Situation:** report that the anti-lock braking system (ABS), traction control (TC) and hill descent control (HDC) warning lamps are illuminated, well-known as “**3 AMIGOS**”.

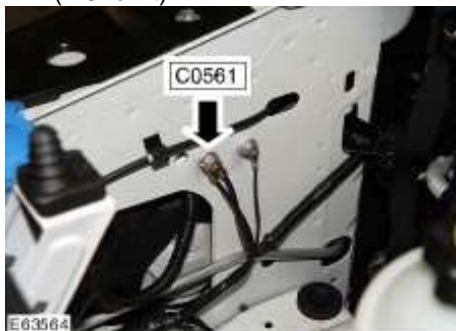
- Inspect the ground stud connection C0561 for damage and corrosion.
- If the ground stud is damaged or corroded clean the eyelet and stud and tighten the nut to 10 Nm (7.5 lbf-ft).

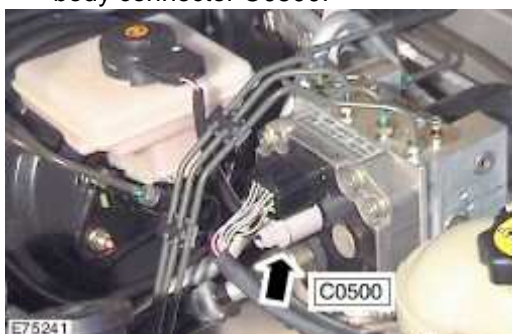
- Check for continuity between the ground stud C0561 and the black wire on the ABS modulator body connector C0500.

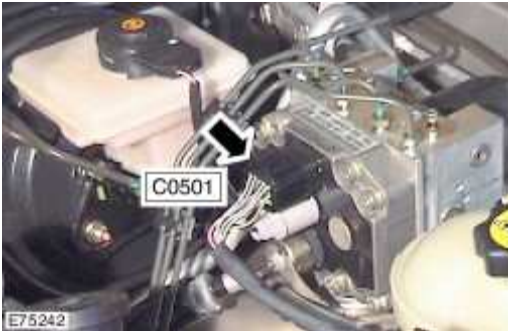
2. Disconnect and check the 13-pin connector at the ABS modulator (C0501)..

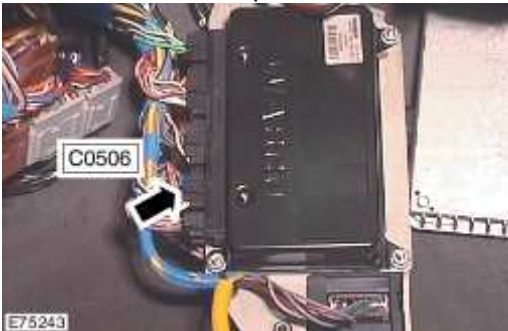
3. Disconnect the 15-pin connector C0506 at the Self Leveling and Anti-lock Braking (SLABS) ECU.

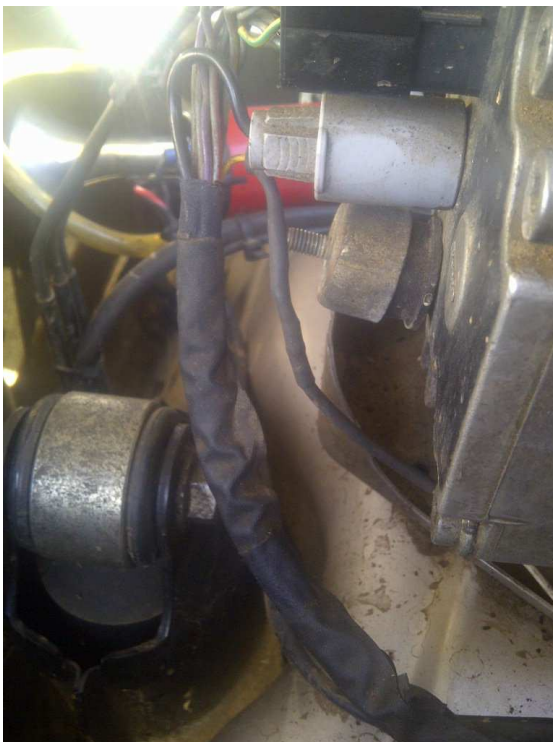
- You should be looking at this..resting on that front bush...

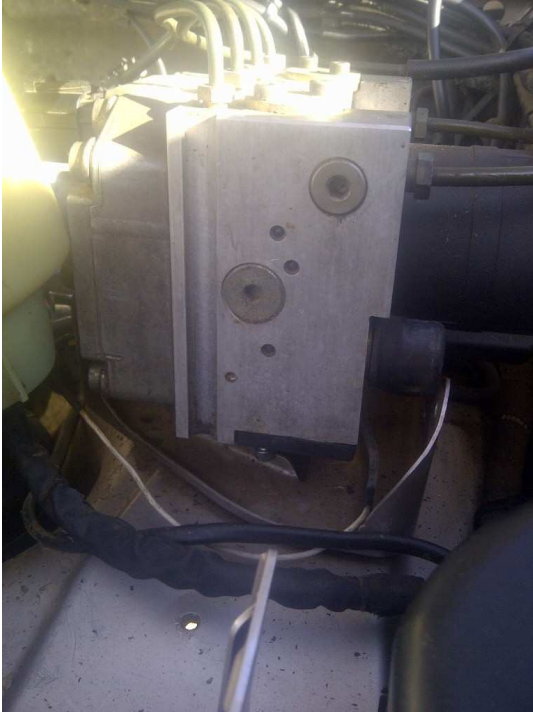
- Here, you can see how far you can get it to lift out of the bracket (ignore the white wire in the picture. you won't have one of those)

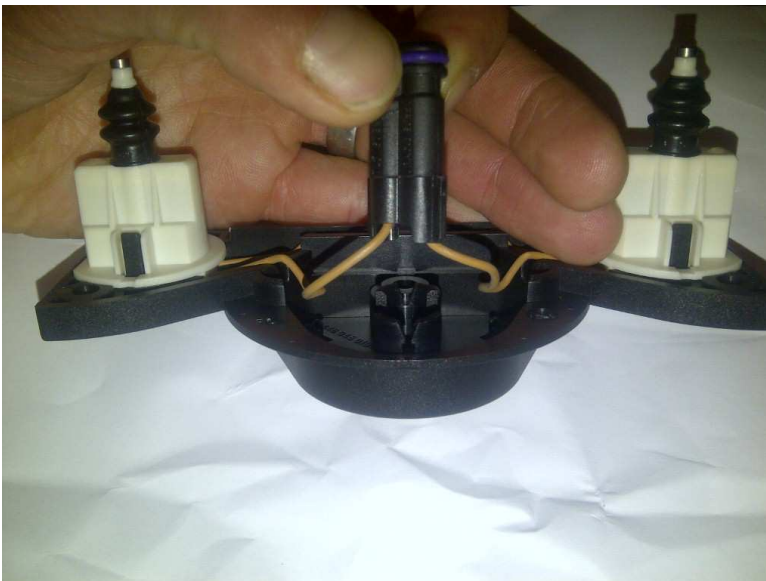
- Now with a combination of the allen key and ratchet spanner (easier) and hex bit, feel your way about underneath around the SVS and find the bolts. It is fiddly and very hard to locate the heads, especially the centre one but it is “doable”. Do the 2 outer ones first, then the centre one...keep the bolts.
- Once the bolts are out, the SVS will pull down out the bottom easily, then pull the multiplug out & gently remove the old one (here pictured a new SVS). Remove multiplug gently.

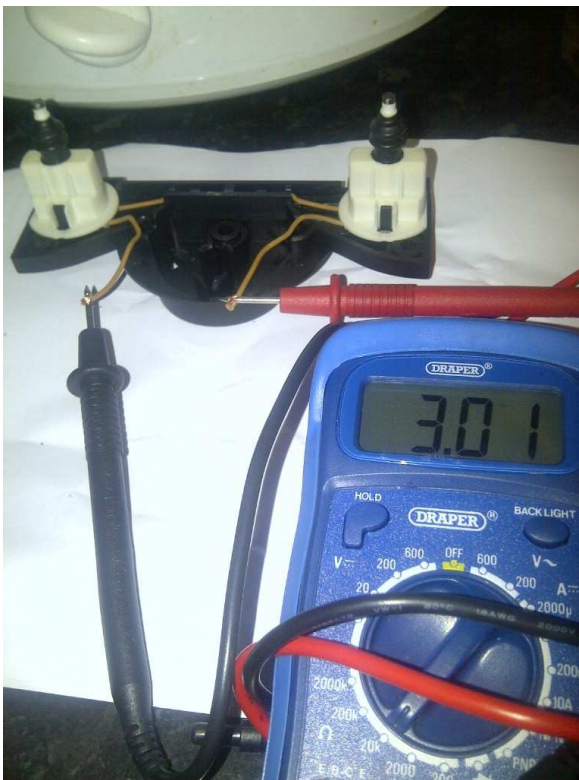
- Now hook up your multimeter as shown below to test the resistance and that the switch is not faulty...  
Strip about 5mm off the ends of the wires...temporarily curl the end so you can hook them up to the Multimeter probes...either probe to either wire...you're just completing a circuit so no worry about polarity.  
Reading 1...both switches open-PASS

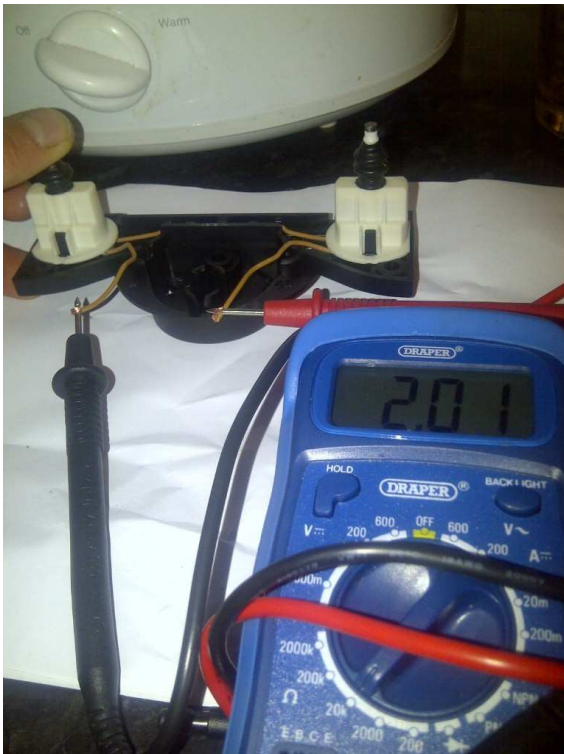
Reading 2...1 switch closed (push one switch down)-PASS

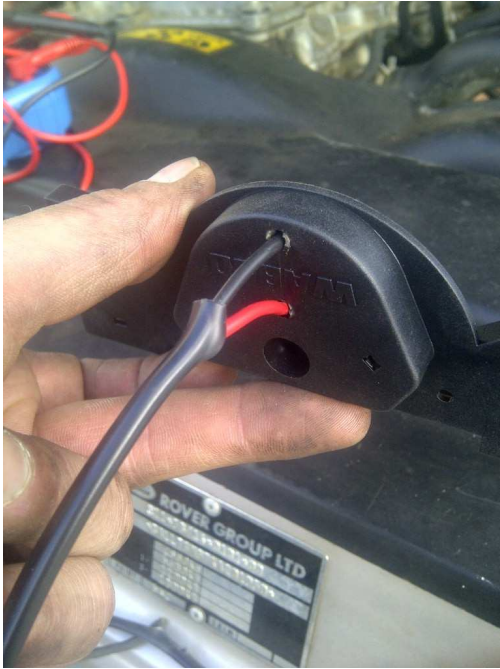
Expose the 2 ends of the twin core by about 3", strip the sheaths to bare cable for inserting in the connectors. The cable needs to be passed through the back of the switch where the original multiplug was you cut off...there are 2 convenient holes here.

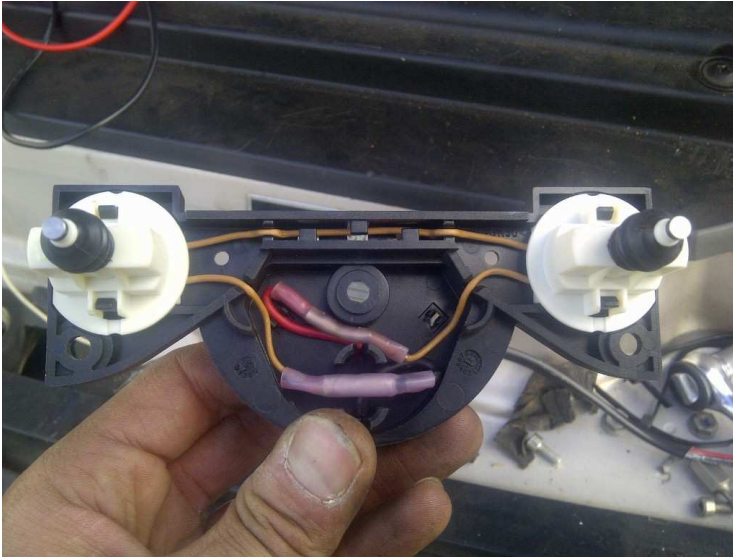
- Once in the switch, employ 2 of your butt connectors and join the new cable to the switch cables you've cut

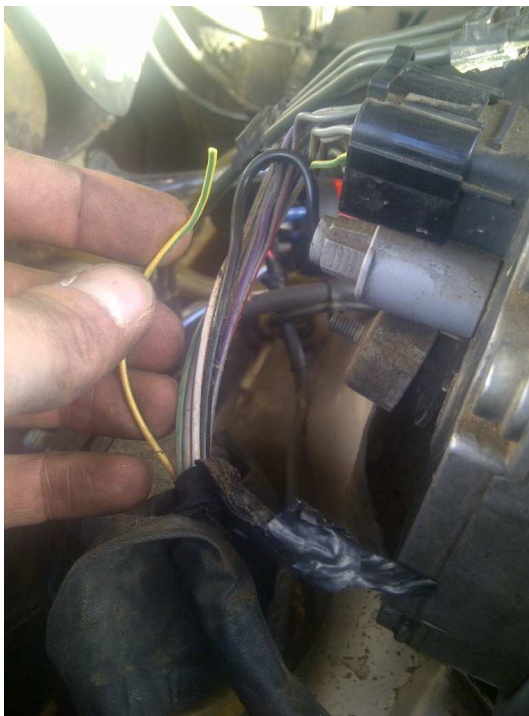
- Test the ends of the new cable as before to ensure the same resistance.
- Now fit the new SVS, reverse of removal...much easier than taking the old one out. Once done, you can now relocate the modulator and bolt it back in
- Now to cut the loom...strip back the outer loom sheath of the modulator multiplug...you need the YG (Yellow/Green) cable...cut it just short of the connector...

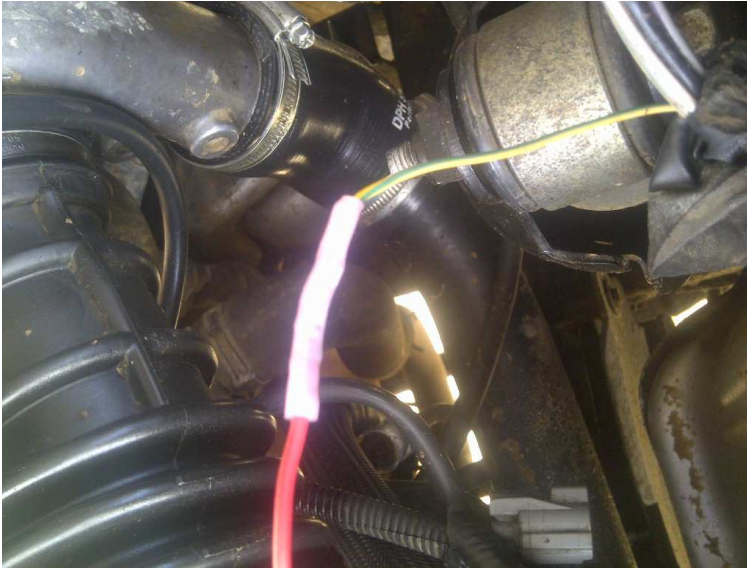
- You can now cut down your twin core to length...I took the red trace of my twin core and used another connector to join the two. Tape it and conduit it.

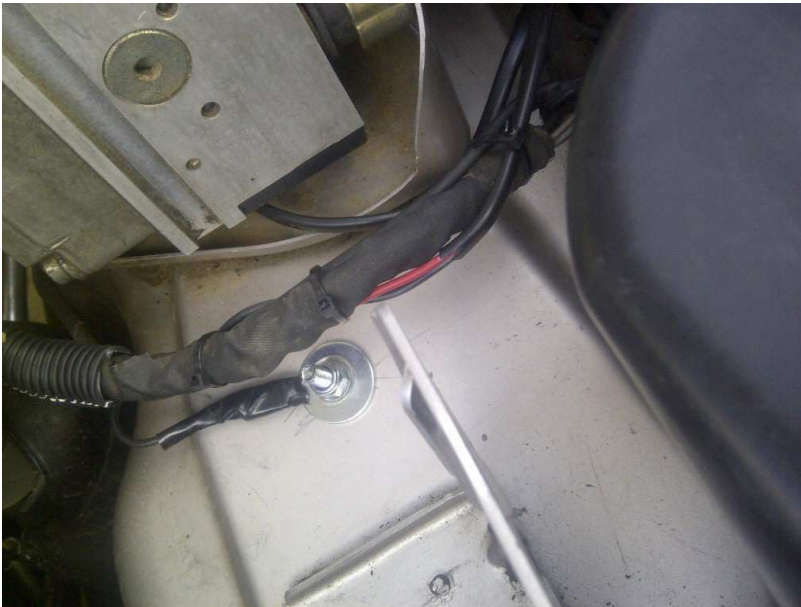
- Take the black trace of your twin core, crimp your ring terminal on the end... It must be grounded somewhere. Between the modulator bracket and the PAS reservoir bracket you will see a hole in the wing .
- If there is nothing already bolted there, remove paint, install a bolt and with a washer and nylock nut you'll get a nice grounding point.
